# Manhole Inspection Summary

Manhole # S27AA\_003MH

Insp Date: **11/28/07 1:48 PM**

**Location** Address: **DOLPHIN ST**

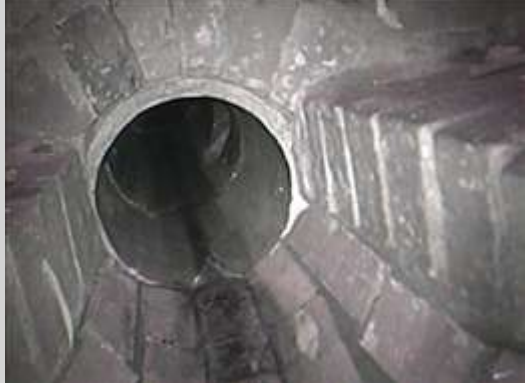
12 O'Clock Outflow

8 in. Circular Gravity Sewer  
Pipe Out @ 12 O'Clock

Pipe Height: (in.) Direct  
Pipe Material: **Clay** ☐ Pipe Lined  
Invert Depth: **10.30** (ft.) Flow Characteristics: **Slow**  
Deposits: ☒ None ☐ Mud ☐ Sludge ☐ Debris ☐ Grease  
Silt Depth: (in.) Deposits Extent:  
Infiltration: **None** Pipe Seal Cond: **Sound**

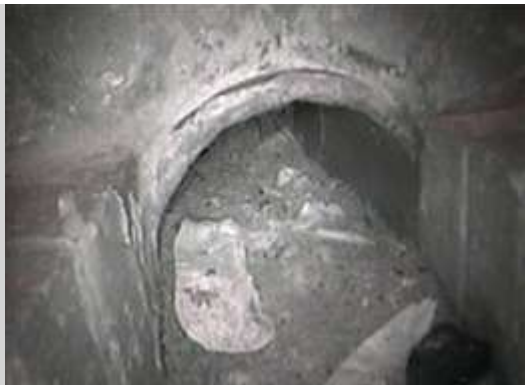
5 O'Clock Inflow

8 in. Circular Gravity Sewer  
Pipe In @ 5 O'Clock

SERVICE LINE, POSSIBLY INACTIVE

Pipe Height: (in.) Direct  
Pipe Material: **Clay** ☐ Pipe Lined  
Invert Depth: **10.18** (ft.) Flow Characteristics: **None**  
Deposits: ☐ None ☐ Mud ☐ Sludge ☒ **Debris** ☐ Grease  
Silt Depth: **2.5** (in.) Deposits Extent: **Medium**  
Infiltration: **None** Pipe Seal Cond: **Sound**

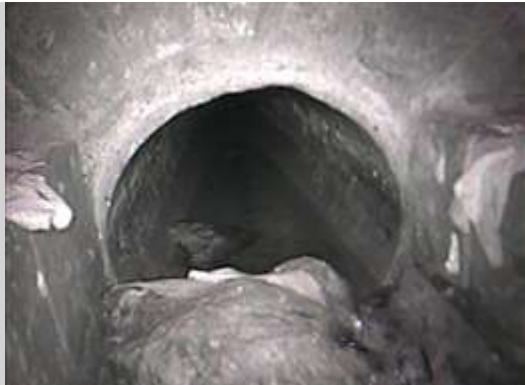
9 O'Clock Inflow

8 in. Circular Gravity Sewer

Pipe In @ 9 O'Clock

Deposits: ☒ None ☐ Mud ☐ Sludge ☐ Debris ☐ Grease

Infiltration: **None** Pipe Seal Cond: **Sound**
